Accurate Inspections of Texas, Inc.

PROPERTY INSPECTION REPORT

By: Samuel A Cunningham # 144
(Name and License Number of Inspector) (Date)

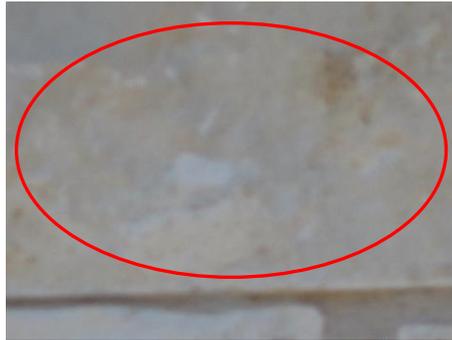
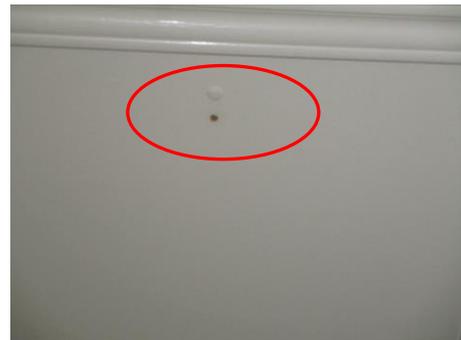
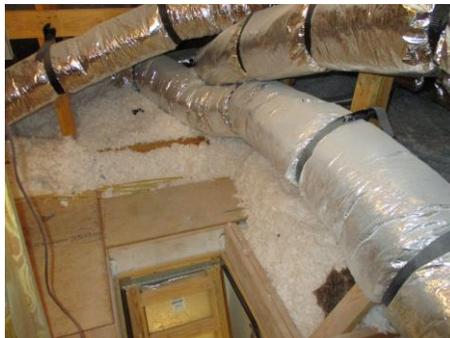
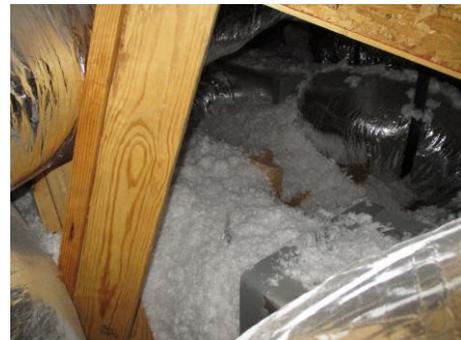
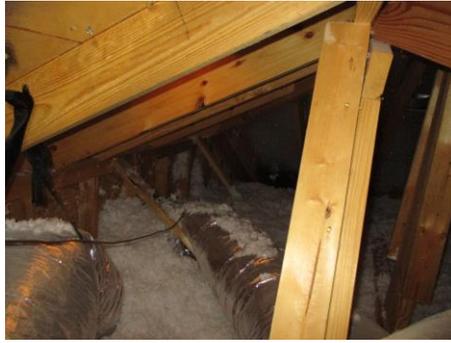
Comments: The soffit area needs to be cleaned or painted on the south side lower level at the back yard. There was no rope for the attic access.

The soffit area needs to be cleaned or painted on the south side lower level at the back yard. There was no rope for the attic access. The screen is missing at the upstairs bath. The windows are too dirty to check fully for fogging. The north window of the upstairs entertainment room did not open.

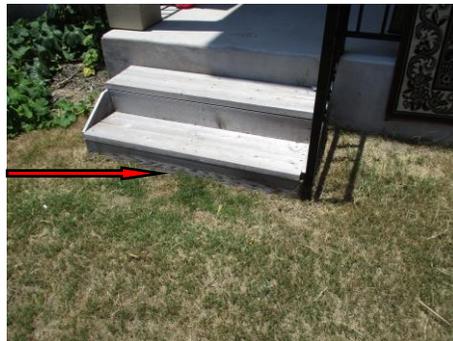
I. Stairways (Interior & Exterior)
Comments: The patio step has wood to ground contact.

The patio step has wood to ground contact.

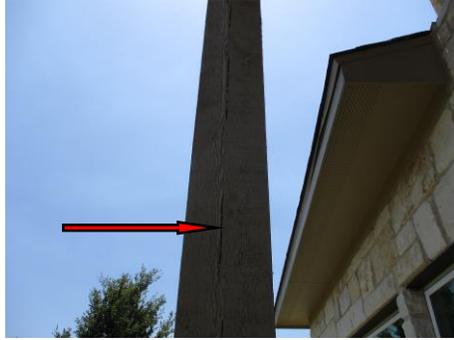
K. Porches, Balconies, Decks, and Carports
Comments: The balcony support post appears to be split. The trim at the support column is not fully painted.

The balcony support post appears to be split. The trim at the support column is not fully painted.

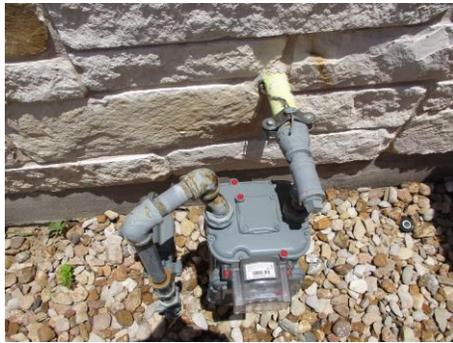
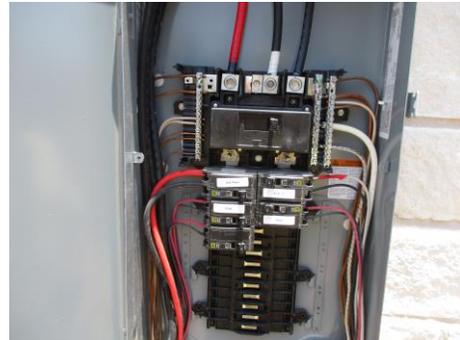
Comments: Be advised, any electrical item checked in the D column may be construed as a possible shock or fire hazard. The grounding rod was not found.

Be advised, any electrical item checked in the D column may be construed as a possible shock or fire hazard. The grounding rod was not found.

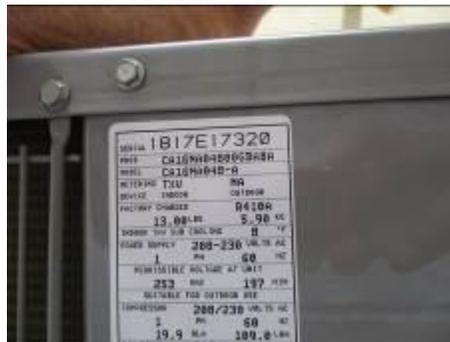
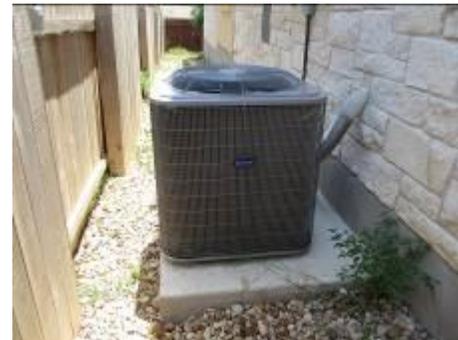
Comments: The AC unit did not appear to be cooling properly. The temperature differential was 22 degrees. I recommend having a licensed professional HVAC technician service and check the unit.

The AC unit did not appear to be cooling properly. The temperature differential was 22 degrees. I recommend having a licensed professional HVAC technician service and check the unit.
