Accurate Inspections of Texas, Inc.

PROPERTY INSPECTION REPORT

By: Samuel A Cunningham # 144
(Name and License Number of Inspector) (Date)

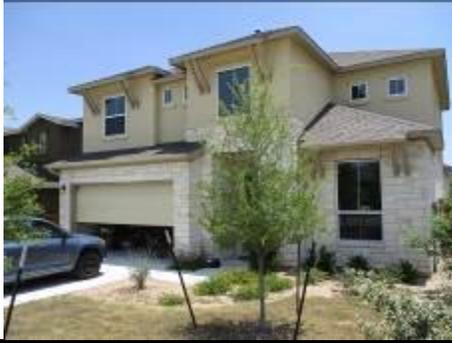
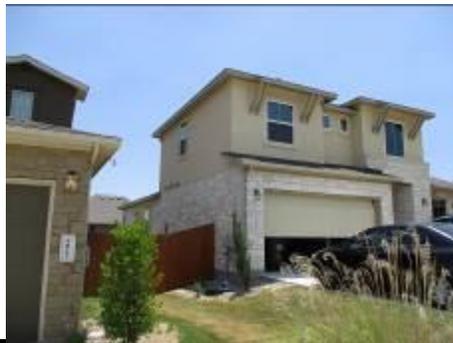
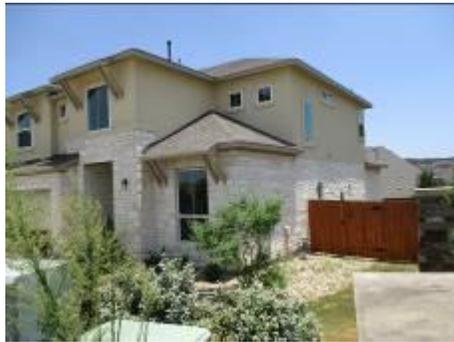
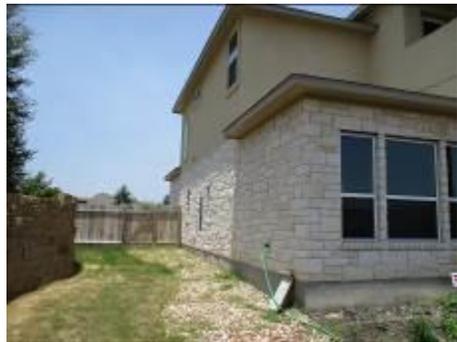
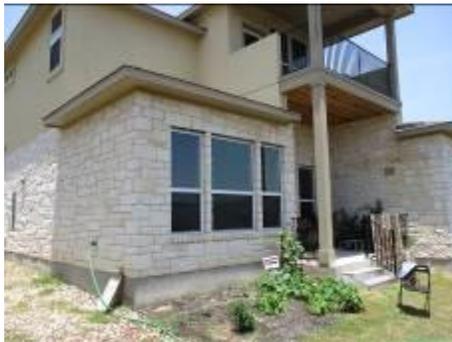
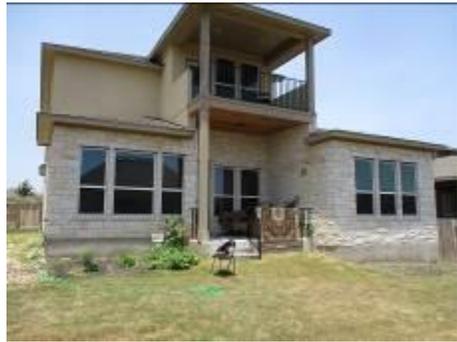
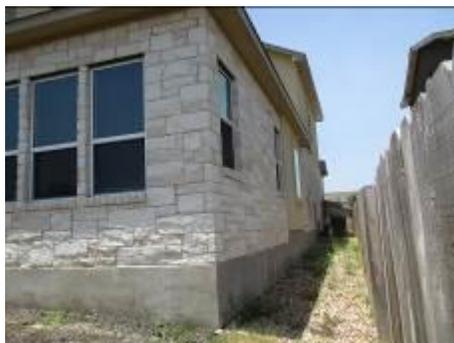
Comments: In my opinion, the foundation appears to be structurally functional at this time. Not all of the foundation is visible due to the floor coverings

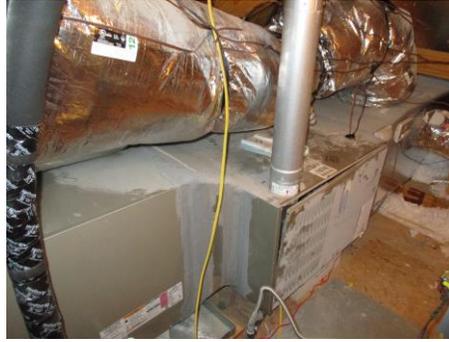
Comments: The AC unit did not appear to be cooling properly. The temperature differential was 22 degrees. I recommend having a licensed professional HVAC technician service and check the unit.
